Smoke and Dye-Water Observation Summary

Western Run Pilot Project - Baltimore Maryland

INSPECTION REPORT

| STREET: DEVONSHIRE DR. 96 B 5 | MAP #1: 1 | MH: 1521105 |

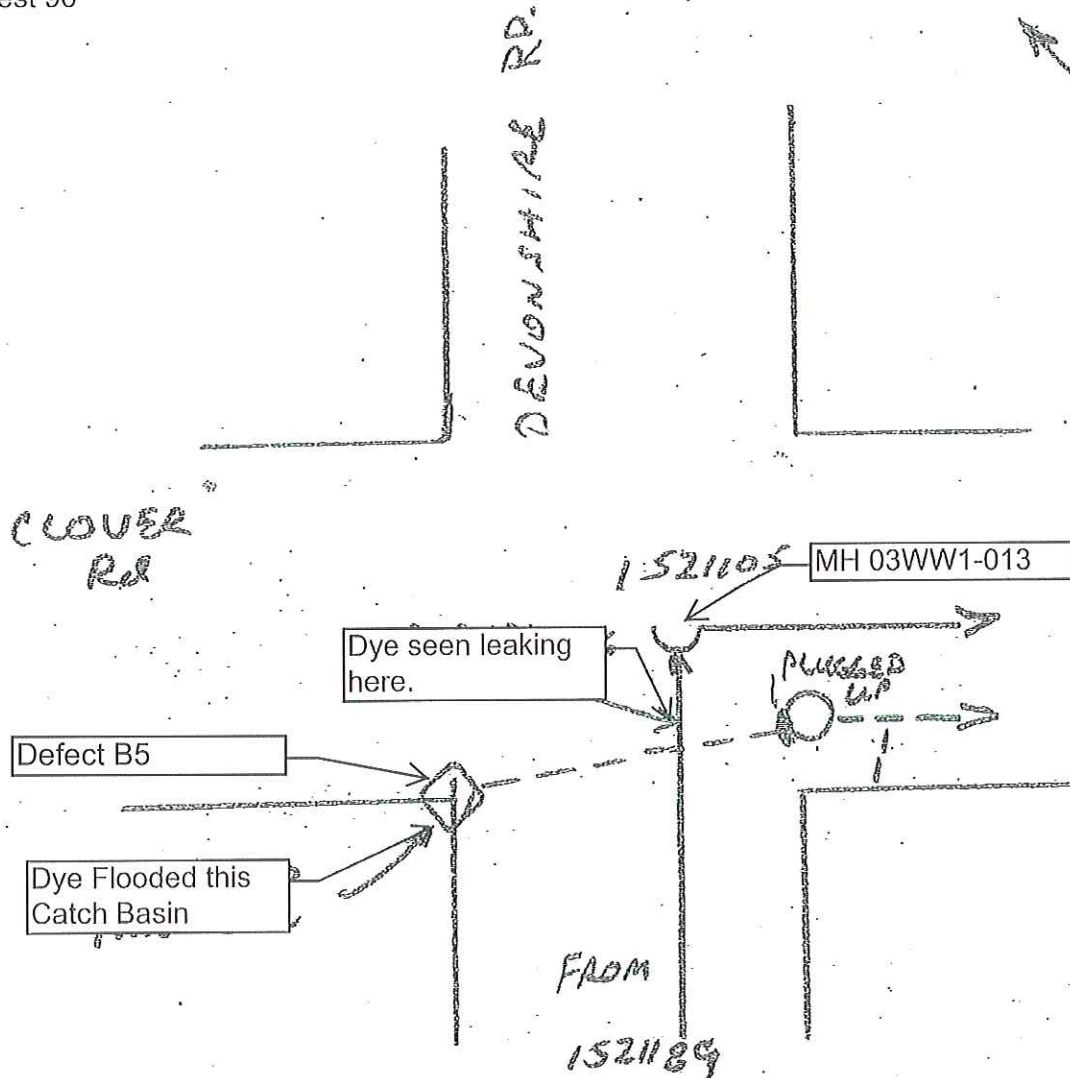
Dye Test 96

Additional Comments: STORM M.H. IS BLOCKED UP WITH
DEBRIS

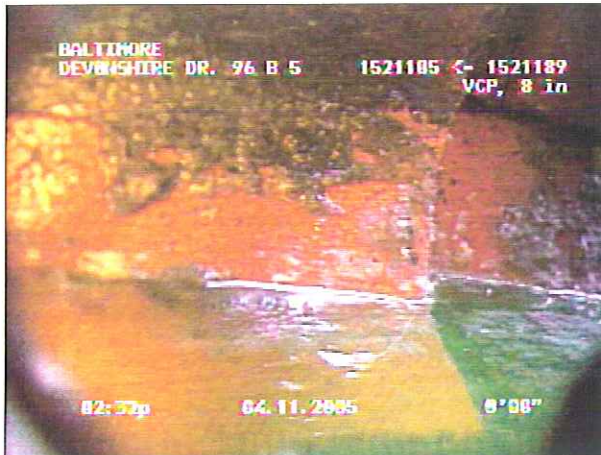
| 1:75 | DIST | OBSERVATION | RATE | VCR # | PH |
|--|---|---|---|---|---|
| | 0.00 | Infiltration Seeping at joint at 04 o'clock | 2 | 00:00:29 | 2a |

IMAGE: 2a, TAPE #: JAM 4, 00:00:29
0FT, Infiltration Seeping at joint at 04 o'clock

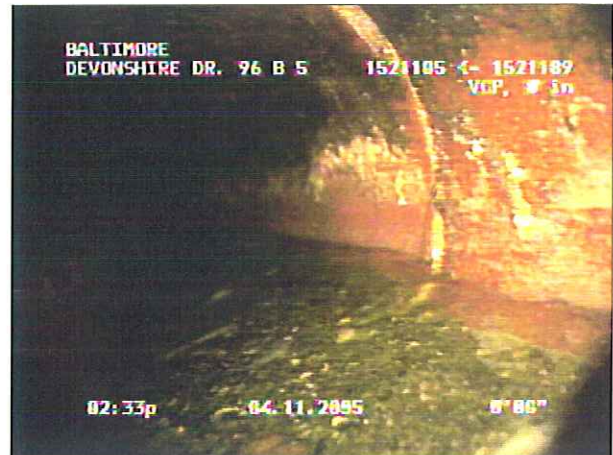
| 1:75 | DIST | OBSERVATION | RATE | VCR # | PH |
|--|---|---|---|---|---|
| | 3.00 | Infiltration Running at joint from 04 to 08 o'clock | 3 | 00:02:07 | 3a, b |

IMAGE: 3a, TAPE #: JAM 4, 00:02:07
3FT, Infiltration Running at joint from 04 to 08 o'clock

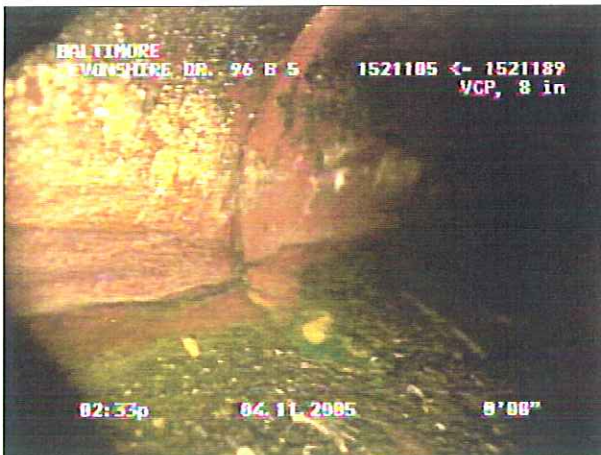
IMAGE: 3b, TAPE #: JAM 4, 00:02:07
3FT, Infiltration Running at joint from 04 to 08 o'clock

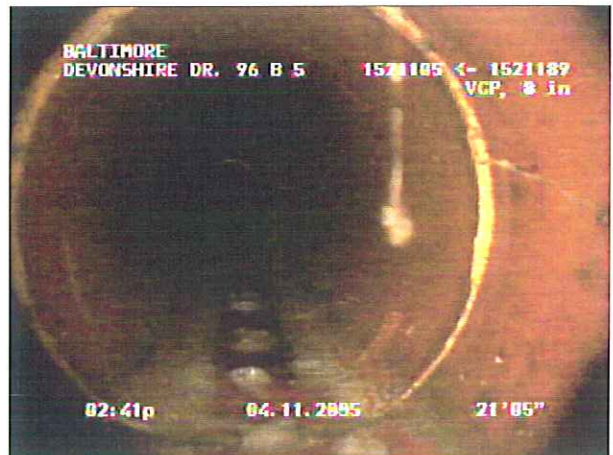
IMAGE: 7a, TAPE #: JAM 4, 00:04:27
21.43FT, inspection ends, NO MORE DYE TEST LEAKS SEEN.
